Electro-desalination of glazed tile panels - discussion of possibilities

Dias-Ferreira, Célia; Ottosen, Lisbeth M.; Ribeiro, Alexandra B.

International RILEM Conference on Materials, Systems and Structures in Civil Engineering

2016

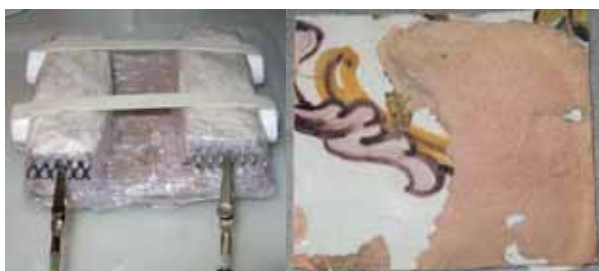
Experiments have been reported with electro-desalination of single tiles in the laboratory [10-12]. The experimental setup of these is illustrated in figure 3a. The tiles were placed with the glaze down and because they had dried out during indoor storage, water was sprayed on the back side before placing the electrode compartments (poultice and inert electrode mesh) as far apart as possible. The tile and electrode compartments were wrapped in plastic to hinder evaporation of water, which would hamper the passage of electric current. A constant current was then applied to the electrodes. Moist pores are needed in order to be able to have passage of current through the biscuit. In cases, where salt decay is problematic, water must be present at least during some periods and it is assumed that it is not neither necessary to add extra water or cover the wall as in the laboratory atmosphere with very low RH.

Figure 3: (a) Experimental setup for desalination of single tile; (b) 20th century tile used in lab experiment.

An experiment with electro-desalination of a Portuguese 20th-century tile (figure 3b) has also been conducted (not previously published). The average initial concentrations were 700 mg Cl^- /kg and 930 mg SO_4^{2-} /kg and thus the salt contamination was much less than the older tiles from Palácio Centeno. After 3 weeks with 1 mA applied 76% Cl^- and 87% SO_4^{2-} were removed. Hereby it was shown that also this biscuit type can be desalinated.

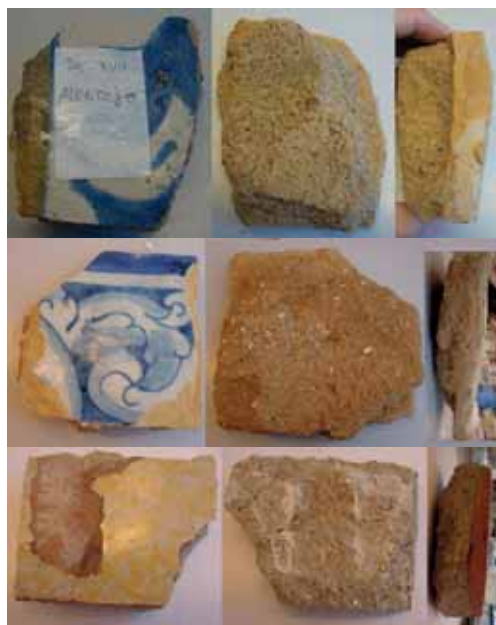
Brammer & Sveegaard [15] and Ferreira et al [16] reported laboratory results with electro-desalination of three tiles from different centuries. Mortar was attached to the tiles in these investigations (see figure 4). Each of the three tiles was broken. The tiles were: 17th-century tile from the Alentejo Region (mortar very hard and unfortunately not considered original), 18th-century tile from Palácio Centeno, Lisbon (mortar very porous and loose, considered original) and 20th-century tile of unknown origin (mortar was hard, but is considered original). Initial samples were taken from both tile and mortar prior to the desalination experiments. From the first two tiles it was only one sample from both. The 20th-century tile was separated into two pieces where one was used to find the initial salt concentration and the other for the desalination experiment.

Figure 4: experimental tiles with mortar. Top: 17th century tile from Alentejo (PT); middle: 18th century tile from Palacio Centeno, Lisbon; bottom: 20th century tile of unknown origin.
